# Manhole Inspection Summary

Manhole # S19II\_002MH

**Location** Address: **1817 N PULASKI ST**

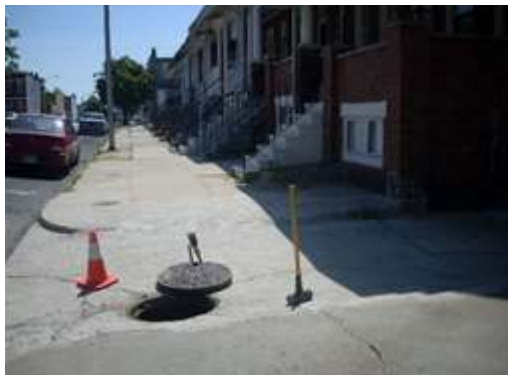
Location View

Comments **LOCATED IN ALLEY - PARTIALLY BURRIED WITH DIRT AND STONE. EXPOSED AND OPENED WITH HAND TOOLS - INSPECTION COMPLETE.**

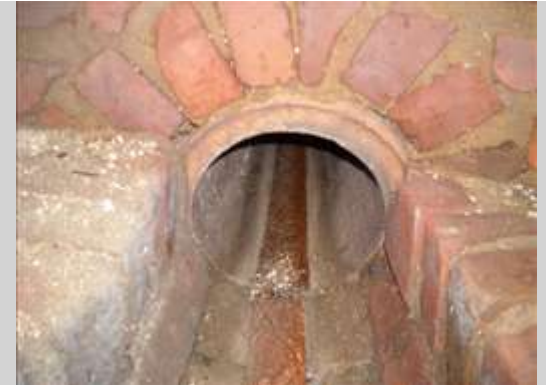
12 O'Clock Outflow

10 in. Circular Gravity Sewer  
Pipe Out @ 12 O'Clock

Pipe Height: **10.8** (in.) Rod and Bar (Angled)

Pipe Material: **Clay** ☐ Pipe Lined

Invert Depth: **9.16** (ft.) Flow Characteristics: **Slow**

Infiltration: **None** Pipe Seal Cond: **Sound**

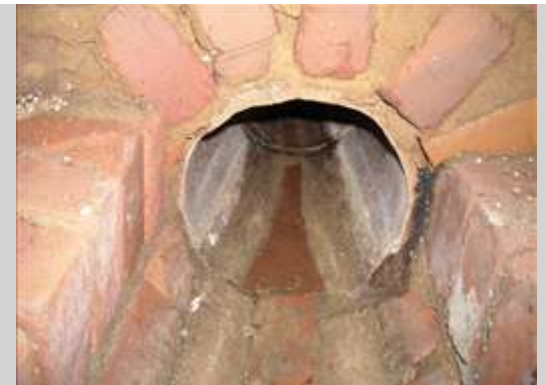
6 O'Clock Inflow

8 in. Circular Gravity Sewer  
Pipe In @ 6 O'Clock

Pipe Height: **8.4** (in.) Rod and Bar (Angled)

Pipe Material: **Clay** ☐ Pipe Lined

Invert Depth: **8.97** (ft.) Flow Characteristics: **Slow**

Infiltration: **None** Pipe Seal Cond: **Sound**

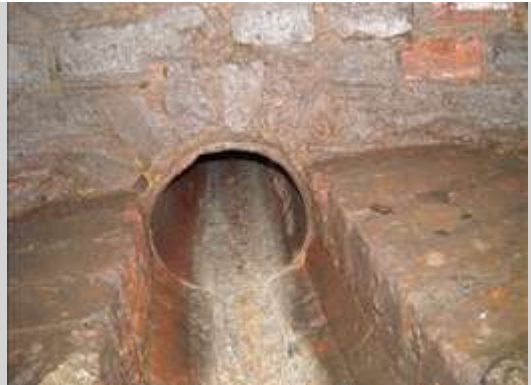
9 O'Clock Inflow

10 in. Circular Gravity Sewer  
Pipe In @ 9 O'Clock

Pipe Height: **9.6** (in.) Rod and Bar (Angled)

Pipe Material: **Clay** ☐ Pipe Lined

Infiltration: **None** Pipe Seal Cond: **Sound**
